Stapleton Mansion Homes
Syracuse Street & 26th Avenue
Denver, CO 80238

Level 2 Reserve Analysis

Report Period – 01/01/13 – 12/31/13

**Draft
Report**

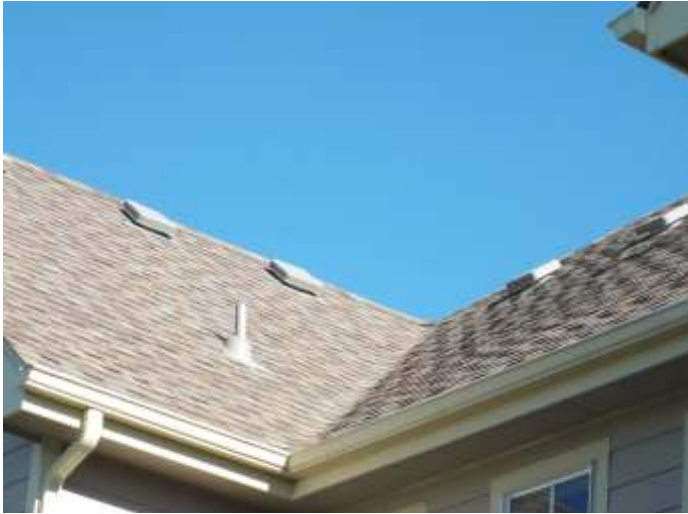
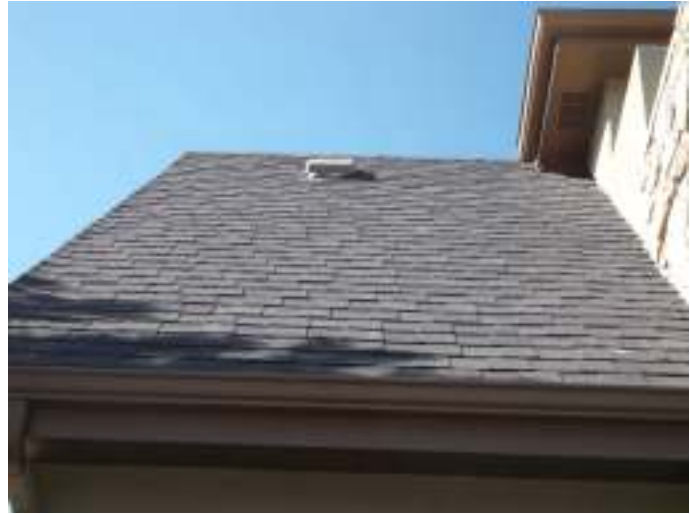
Comp #: 105 Pitched Roof - Comp Shingle - Replace

Comp shingle roofs appeared in good to fair condition at time of observation with only minor loss of surface granules apparent. This roof appears to be a "30-year" rated shingle. Despite this rating, replacement typically needs to occur within 15 - 20 years due to weather elements such as hail, wind, and temperature fluctuations. Reserve funding includes complete tear off and replacement.

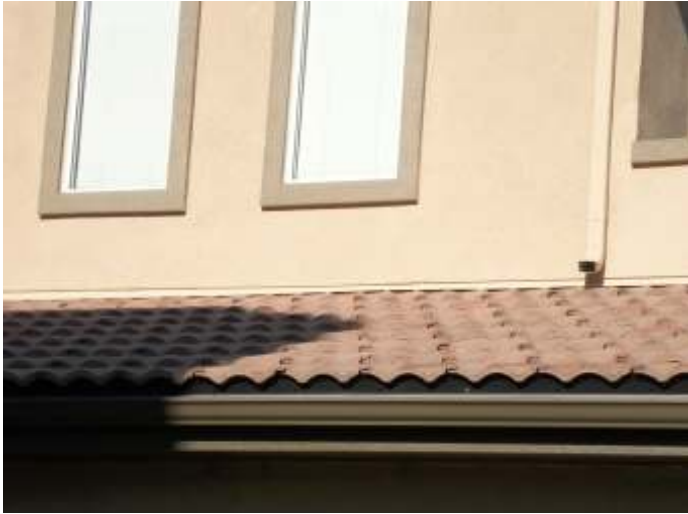
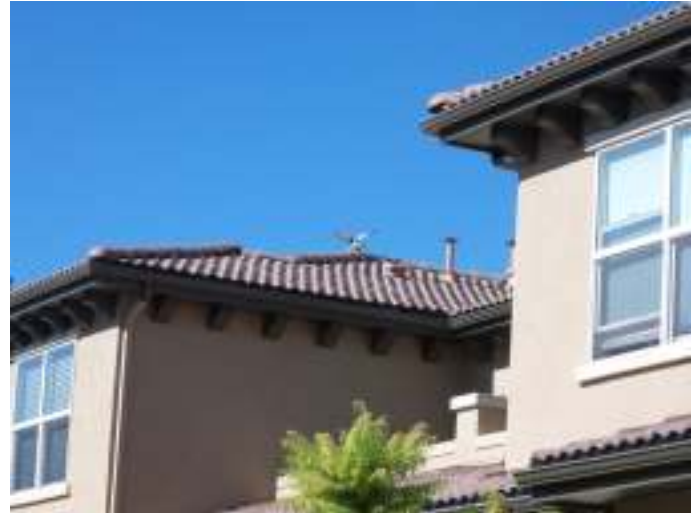
Comp #: 106 Pitched Roof - Tile - Replace

Unable to access roofs due to the height of roof. While the tiles act as the primary water barrier from intrusion into the building, the underlayment (usually a 40 lb felt fabric) also is very important in protecting the building from water intrusion. This underlayment will typically require replacement every 20 - 25 years in this environment. Replacement of underlayment involves removal of roof tiles, replacing the underlayment and reapplying the tiles. Some broken tiles are inevitable as the labor involves moving the tiles. Reserve to replace the underlayment and replace some tiles every 22 years based on industry standards in this environment.

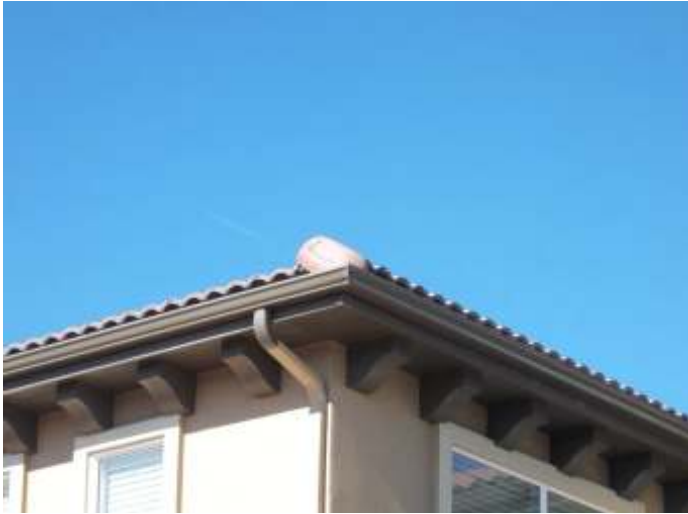
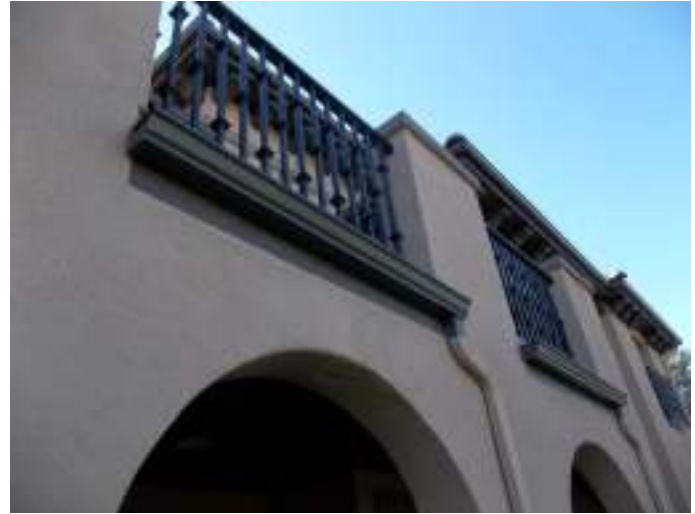
Comp #: 120 Rain gutters/Downspouts - Replace (tile roofs)

These rain gutters and downspouts are new and no unusual conditions were observed during inspection. Average life expectancy ranges from 20 - 25 years. It is typical to replace rain gutters and downspouts at the same time as roof materials, however, the rain gutters were reported to have been replaced in 2010/11 during a reconstruction project. Therefore, Reserve to replace in approximately 27 years. It is also important to clean lines at least once a year to ensure proper drainage and prevent clogging.

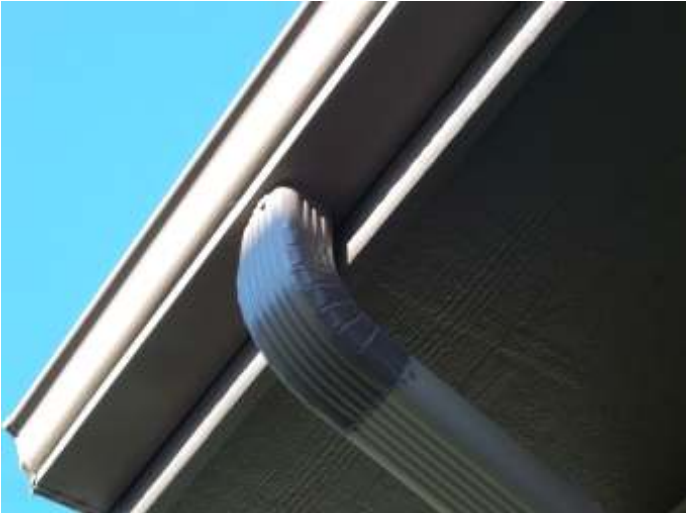
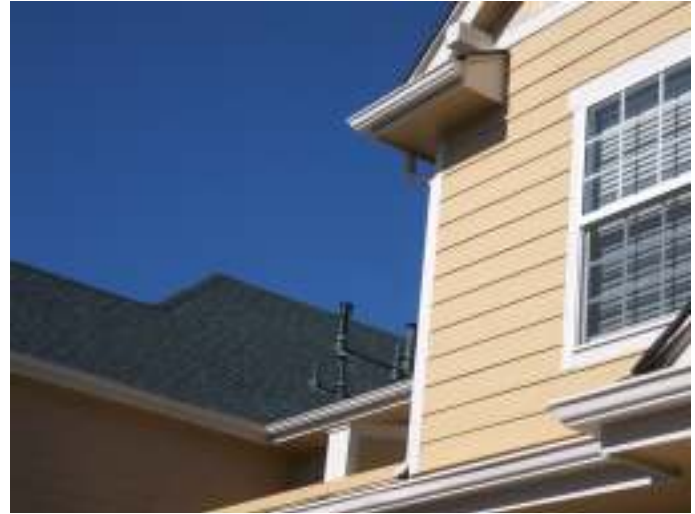
Comp #: 120 Rain gutters/Downspouts - Replace (comp roofs)

These rain gutters and downspouts are new and no unusual conditions were observed during inspection. Average life expectancy ranges from 20 - 25 years. It is typical to replace rain gutters and downspouts at the same time as roof materials, however, the rain gutters were reported to have been replaced in 2010/11 during a reconstruction project. Therefore, Reserve to replace in approximately 17 years. It is also important to clean lines at least once a year to ensure proper drainage and prevent clogging.

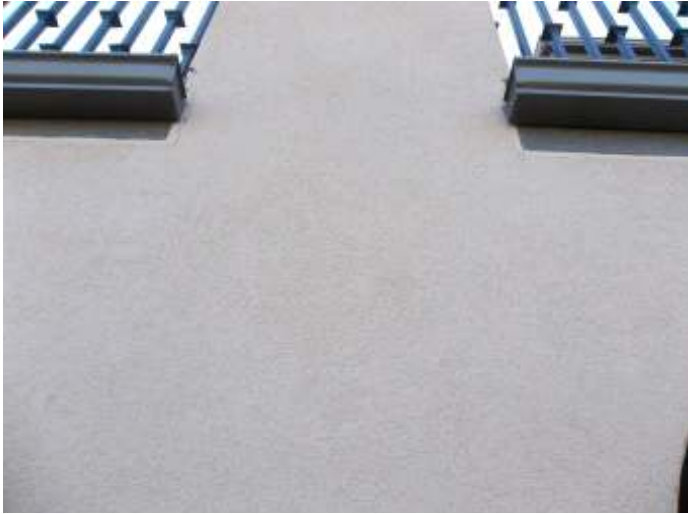
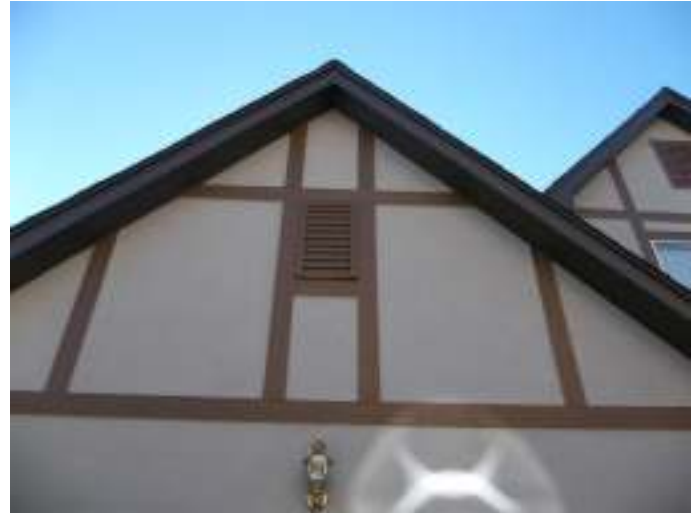
Comp #: 201 Building Ext. Surfaces - Repaint

It was reported that the unit buildings were repainted as a part of reconstruction projects in 2010/11 and are in very good condition at time of observation. It is recommended that the fiber cement product is painted every 8 - 10 years due to the type of material. While stucco has a long life expectancy, it is recommended that a new coating is applied every 10 - 12 years to maintain the appearance. Since both surfaces average a painting cycle of 10 years, we recommend painting or reapplying approximately every 10 years. Painting should coordinate with trim for best cost estimate.

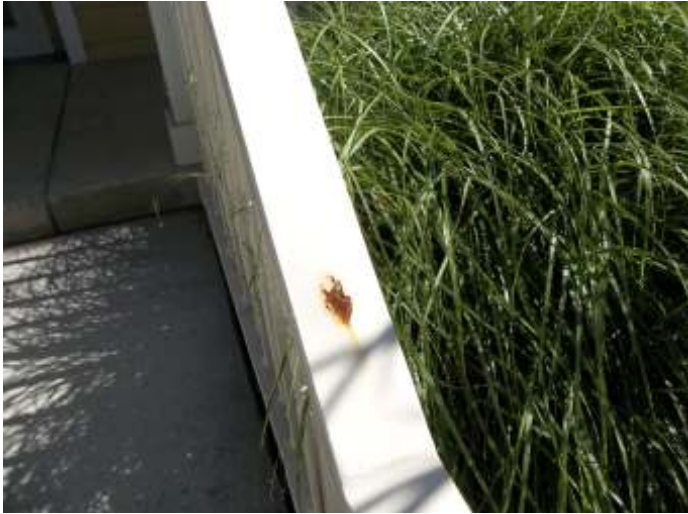
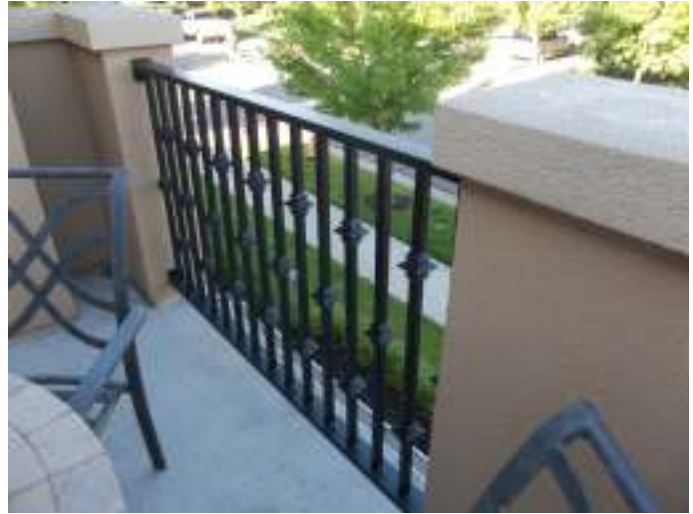
Comp #: 202 Building Trim - Repaint

It was reported that the trim was repainted as part of a reconstruction project in 2010/11 and appeared in good to fair condition at time of observation. Majority of front doors are covered and well protected from direct exposure to elements. With new communities, it is expected to repaint a couple years within completion of construction. This is typical since most new construction is painted with only one coat of paint. The paint materials absorb into the wood, causing a thin coat that will be subject to fading and deterioration sooner than normal. Once a new coat of paint is applied, a typical repainting cycle of 4 - 5 years can be expected. Painting cycle should coordinate with siding for best cost estimate.

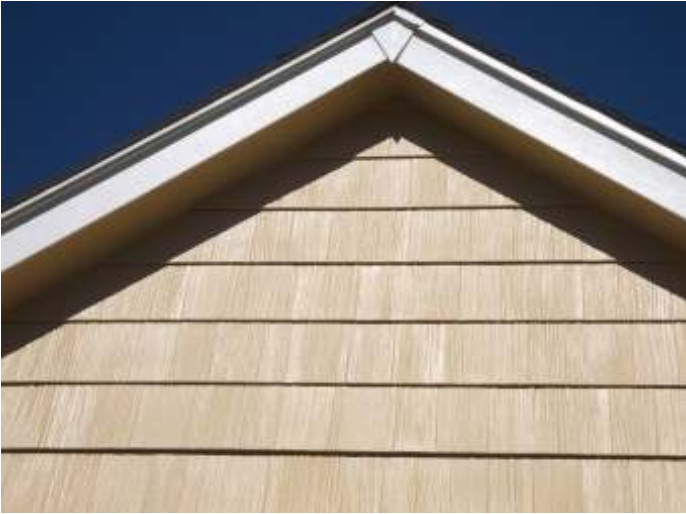
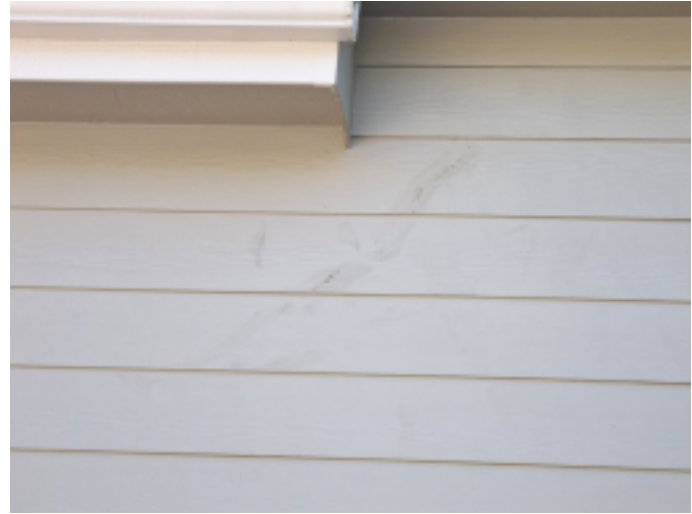
Comp #: 304 Cement Fiber Siding - Major Repairs

This community is a relatively young community and therefore, the siding is in very good condition with no overt signs of damage or deterioration at the time of our observation. However, as the community ages, frequent high winds, hail, driving rain, and the freeze thaw cycle will eventually start to damage the fiber cement. Therefore, we recommend reserving for major repairs every paint cycle in order to avoid complete replacement of the siding in the future. This reserve designation is for repairs that lie outside the scope of routine paint prep operations.

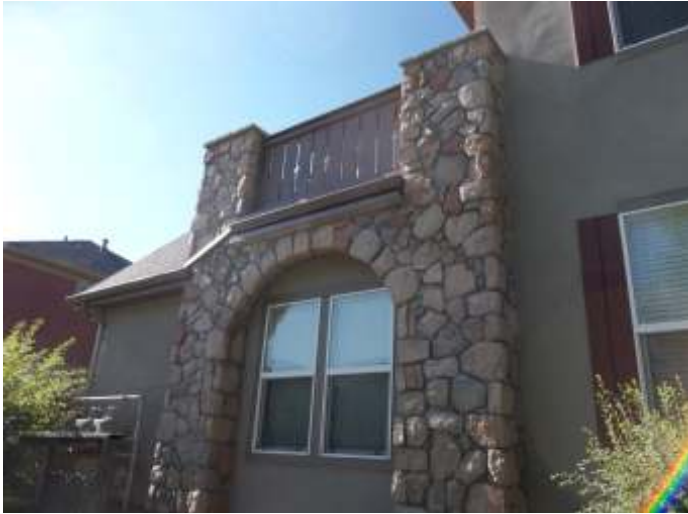
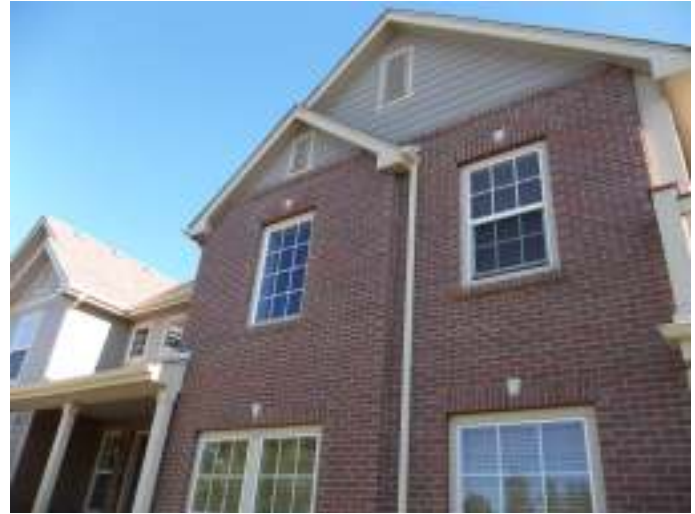
Comp #: 305 Brick/Stone - Replace

No unusual conditions of loose bricks or stones noted at time of observation. As long as the materials were installed properly, they should have an extended life expectancy and replacement is not likely. Therefore, no reserve funding is required for this component at this time.

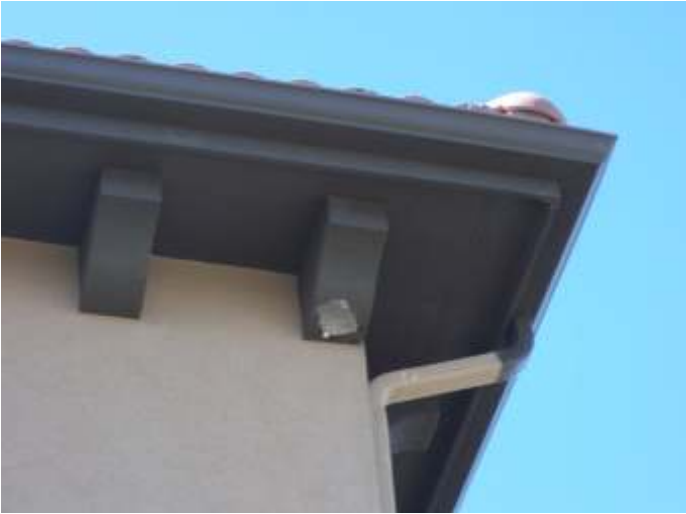
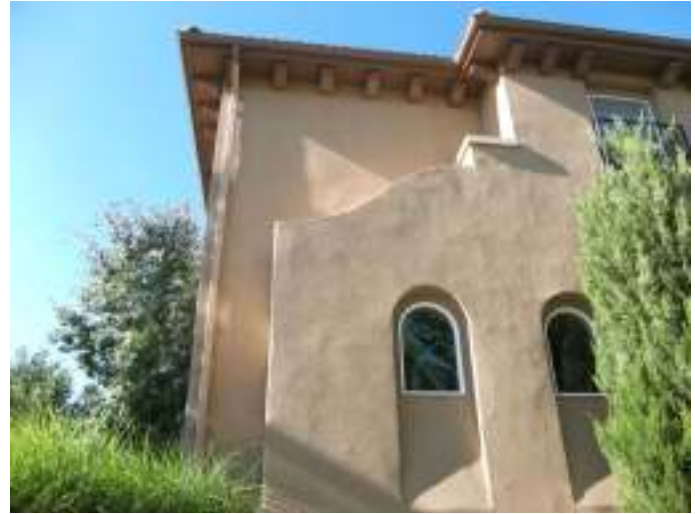
Comp #: 308 Stucco - Repair

As part of a reconstruction project, stucco surfaces on nearly every building (with stucco) was repaired and brought up to satisfactory levels. All surfaces are in good condition with only minimal hairline cracking observed (typical). While stucco surfaces have a long life expectancy, it is recommended by industry professionals that it is inspected and any voids are repaired every 5 years to prevent water intrusion into substrate. It is also recommended that a new coating is applied every 10 - 15 years to maintain an appropriate appearance (see component #201). Over a period of time, minor cracks and voids will develop that will require repairing.

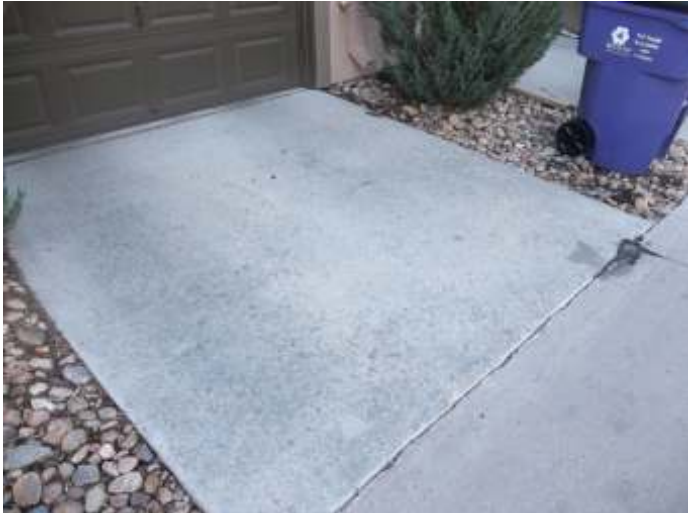
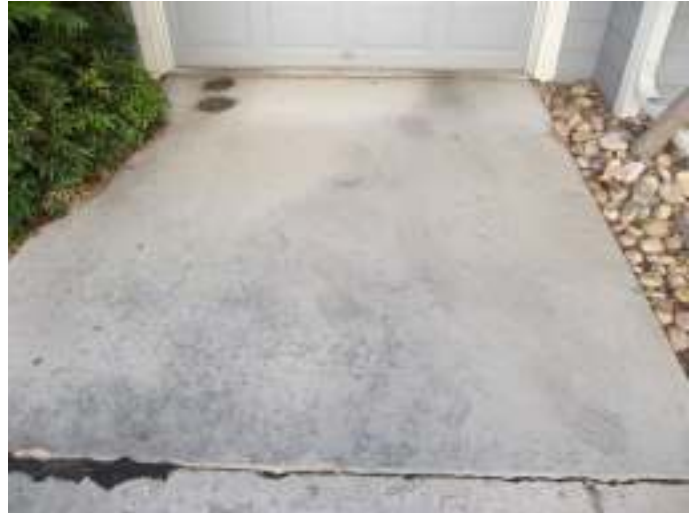
Comp #: 403 Concrete - Repair/Replace

Majority of concrete surfaces are in good condition with some minor spalling and hairline cracks. Concrete is subject to deterioration in this climate due to freeze/thaw conditions and soil expansion. While we do not expect all concrete surfaces to require replacement at the same time, we do anticipate periodic repairs to approximately 10% of area (1200 GSF) every 4 years.

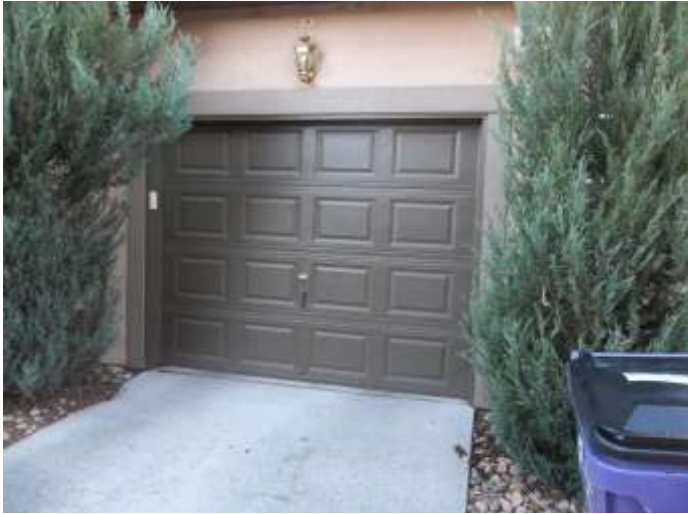
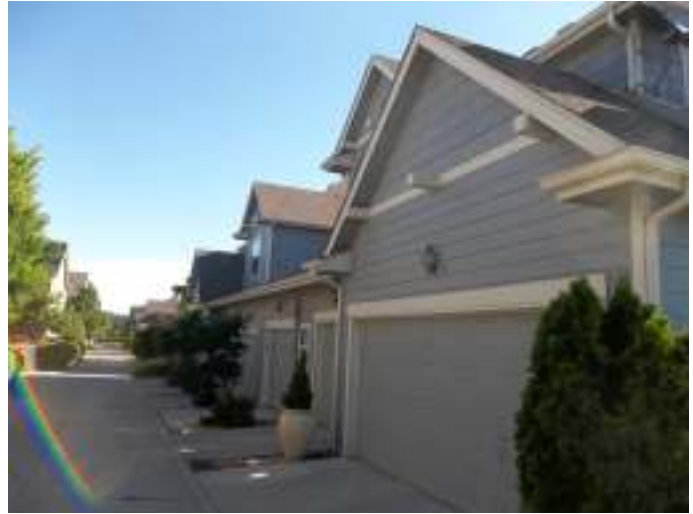
Comp #: 502 Garage Doors - Replace

It was reported by client at time of observation (2012) that the garage doors are the responsibility of the individual homeowner. The association will paint the garage doors during normal paint cycles (see component #201) but the repair and/or replacement is up to the homeowner. No reserve funding recommended for garage door replacement.

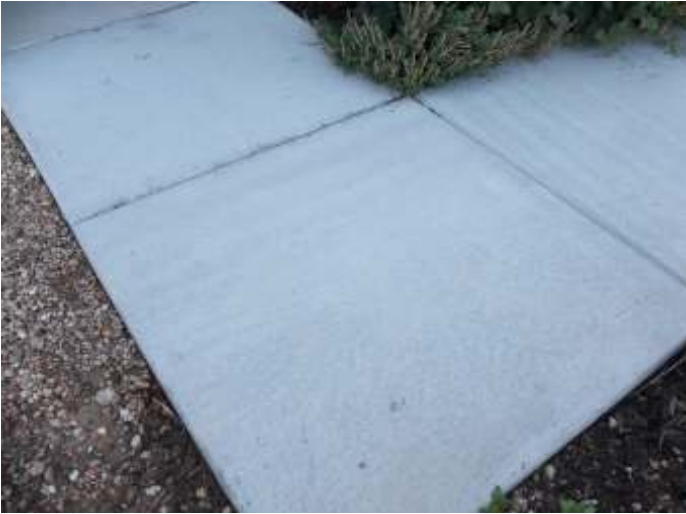
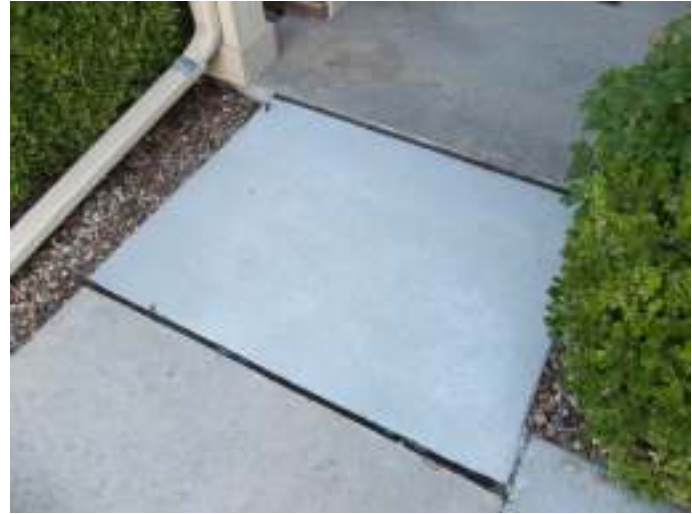
Comp #: 601 Concrete Sidewalks/Decks - Repair

During a reconstruction project recently completed, many areas of new concrete were installed and in very good condition. However, areas of minor spalling and some cracking in the older concrete was apparent. Similar to concrete driveways, it is highly unlikely that all concrete surfaces will fail at the same time and need replacement. Therefore, we recommend establishing a Reserve fund for periodic repairs to approximately 10% of area (1470 GSF) to the sidewalks every 4 years. Coordinate repairs with driveways for best cost estimate.

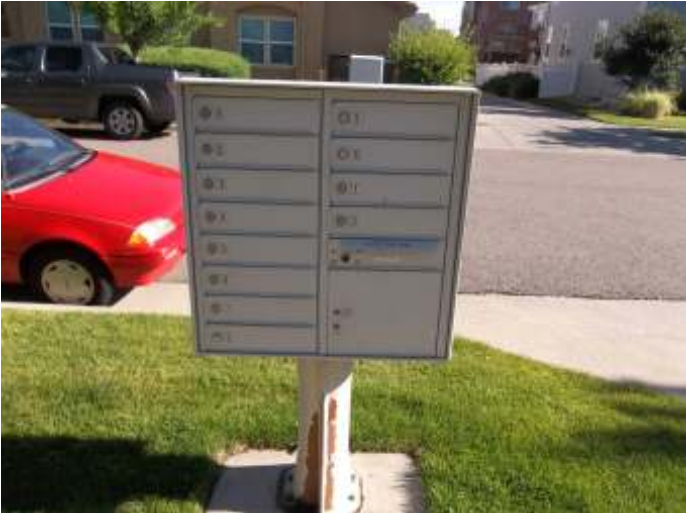
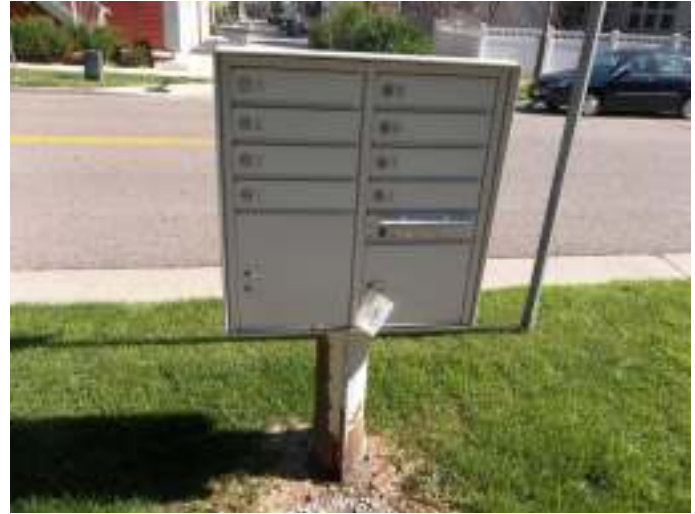
Comp #: 803 Mailboxes - Replace

These are the responsibility of the US Post Office and not the association. However, the Post Office will not typically paint or maintain the bases of the cluster boxes, the bases are rusting badly and have become an eyesore. We recommend painting the bases as needed using operating funds in order to maximize the life expectancy of the units as well as provide an appropriate appearance for the community. No Reserve funding is required for this component.

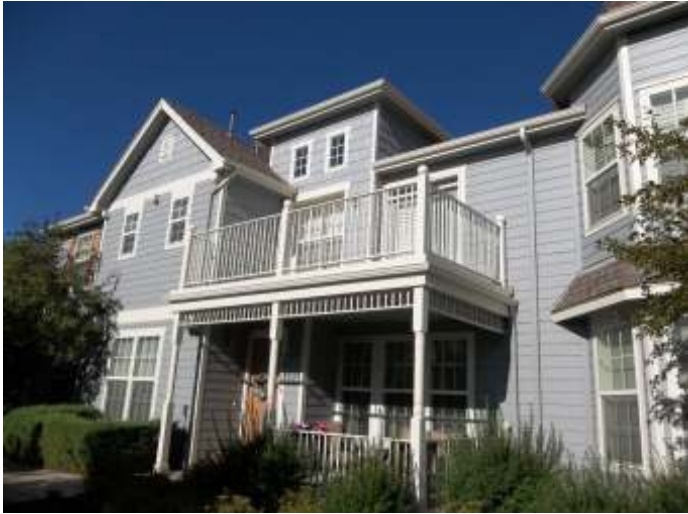
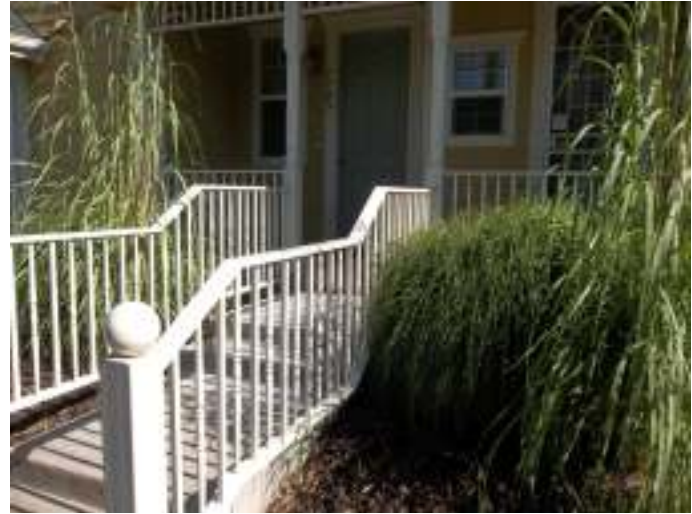
Comp #: 1002 Iron/Wood Railing - Replace

During the recent reconstruction project, many of the rails around decks and along paths of egress were either refurbished or replaced and appeared in very good condition with no rusting, warping or other issues noted or reported. With proper maintenance cycles of painting every 2 - 3 years (see component #202), the life expectancy of these surfaces should range from 25 - 30 years. Majority of the surfaces are not exposed to irrigation spray and constant moisture, so the maximum useful life should be attained.

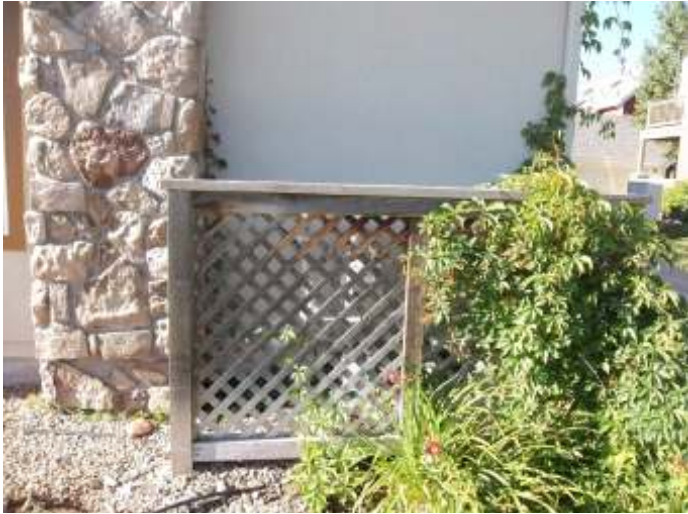
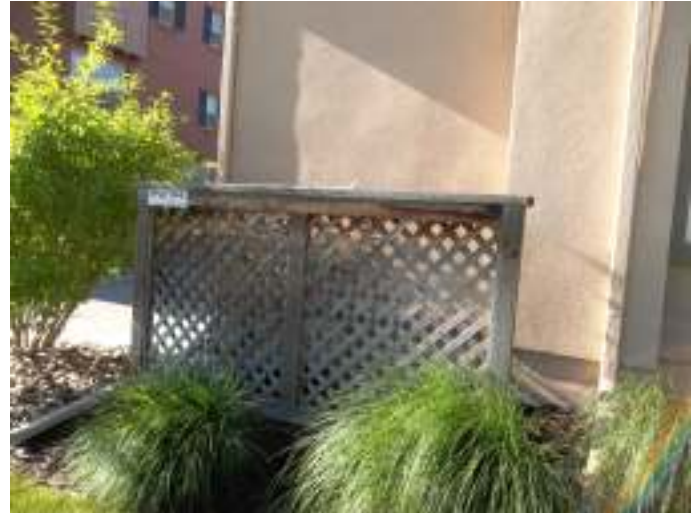
Comp #: 1004 Latticework - Replace

Each building has a small fence to hide the utility area on the sides of the buildings. Due to small areas on each building (10' each building), we suggest replacing and staining these fences on an as needed basis with operating funds. Therefore, no Reserve funding is required for this component.

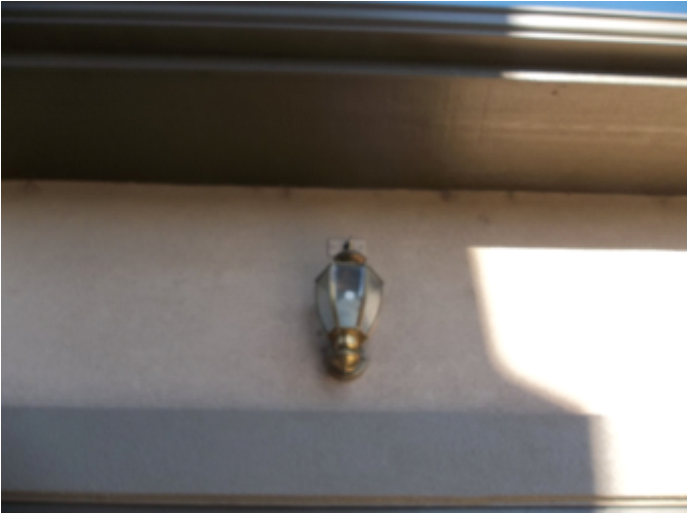
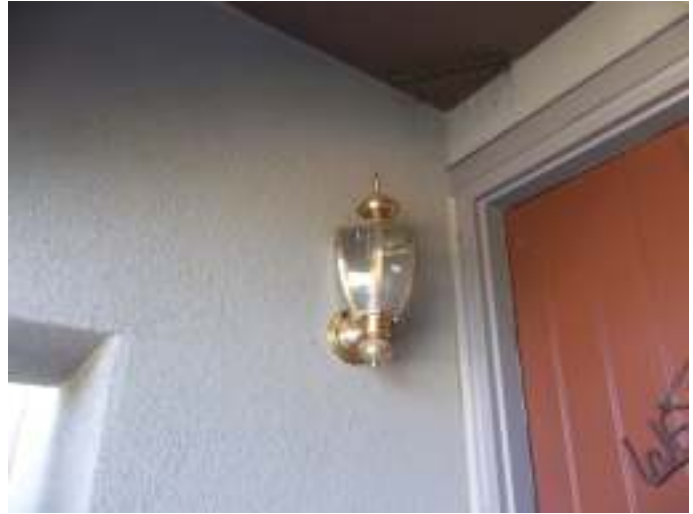
Comp #: 1602 Exterior Wall mount - Replace

No unusual conditions observed or reported at time of observation. While replacement can occur on an as needed basis, it is our opinion and recommendation to replace all lights at the same time every 15 - 20 years to maintain a consistent appearance throughout the property. In addition, by replacing multiple fixtures, the association will be able to obtain a quantity discount for the fixtures. Estimated replacement cost includes labor for installation.

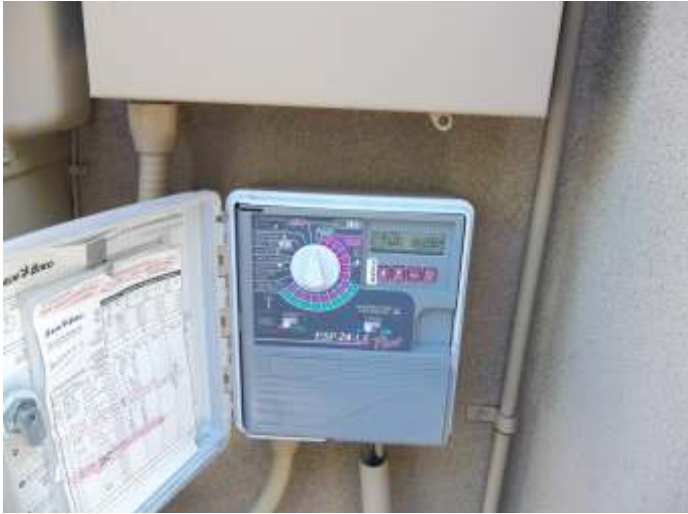
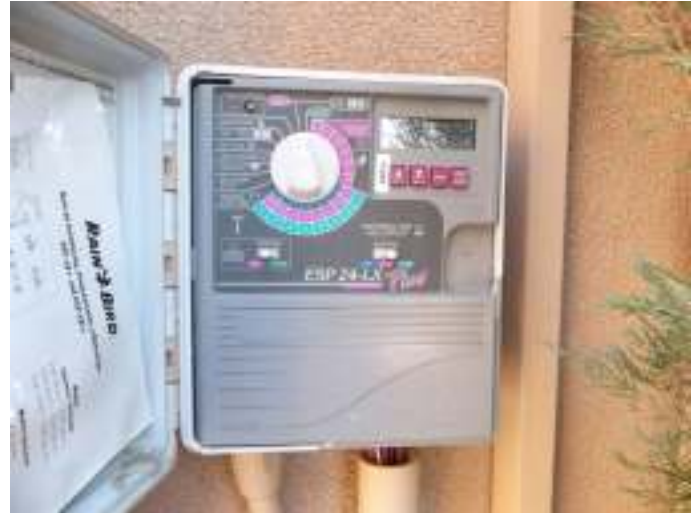
Comp #: 1703 Irrigation Timeclocks - Replace

No problems reported or noted at time of preparing this report. Under normal conditions (not including Acts of God, vandalism, etc.) these clocks should last 10 - 12 years with proper maintenance. Due to advances in technology and water efficiency, we suggest reserving to replace all clocks at the same time. A lot of communities are upgrading to ET type controllers and the costs reflect this. Remaining useful life based on average age of all clocks.

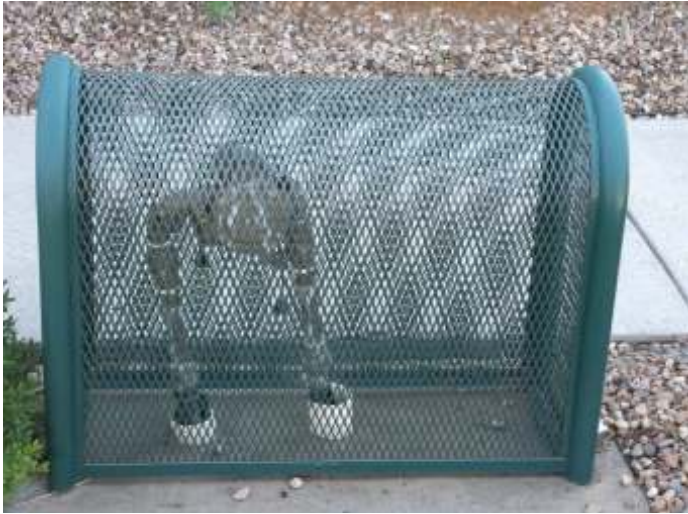
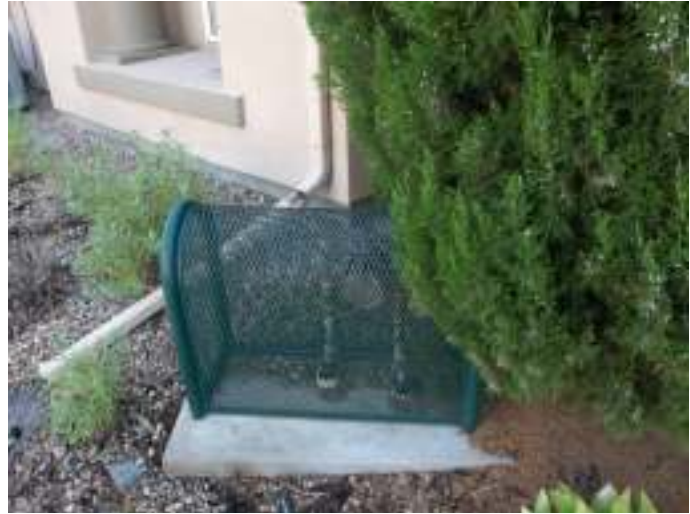
Comp #: 1704 Backflow Enclosures - Replace

It was reported that these enclosures were installed in 2008 to protect from theft of the copper components of the devices. Although these enclosures can be replaced as needed using operating funds, we recommend reserving to replace all of them at the same time since they were all originally installed at the same time. Paint the enclosures as needed using operating funds while reserving to replace all enclosures every 20 years.

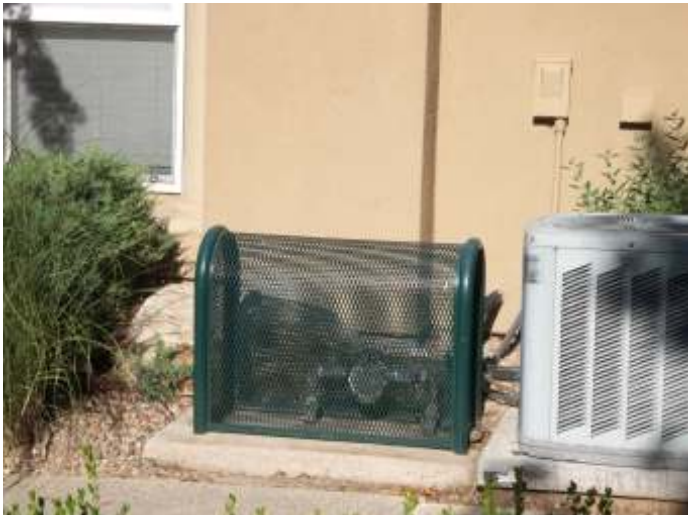
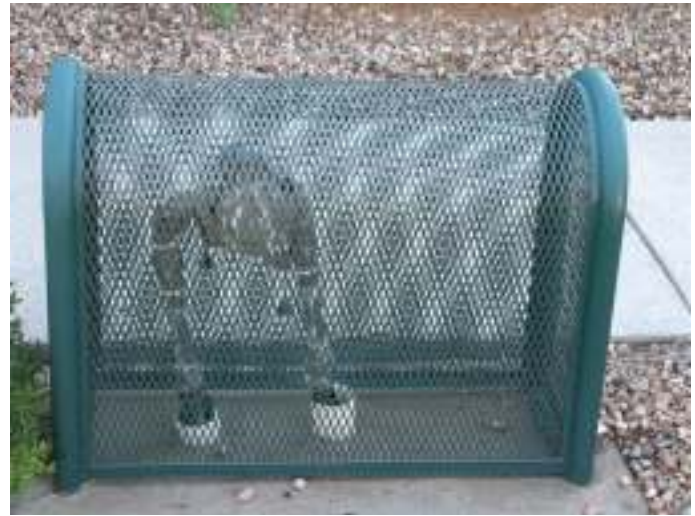
Comp #: 1706 Backflow Devices - Replace

Since property is relatively new, assume all devices comply with code requirements. There were no unusual conditions observed with devices at time of inspection. It is difficult to predict a life expectancy for backflow preventers. Often, the device can be rebuilt as opposed to being completely replaced. Treat any repairs as needed as a general maintenance expense. No separate Reserve funding is required for this asset.
